Intel[®] Pentium[®] II Xeon[™] Processor Specification Update

Release Date: September 2000

Order Number: 243776-024

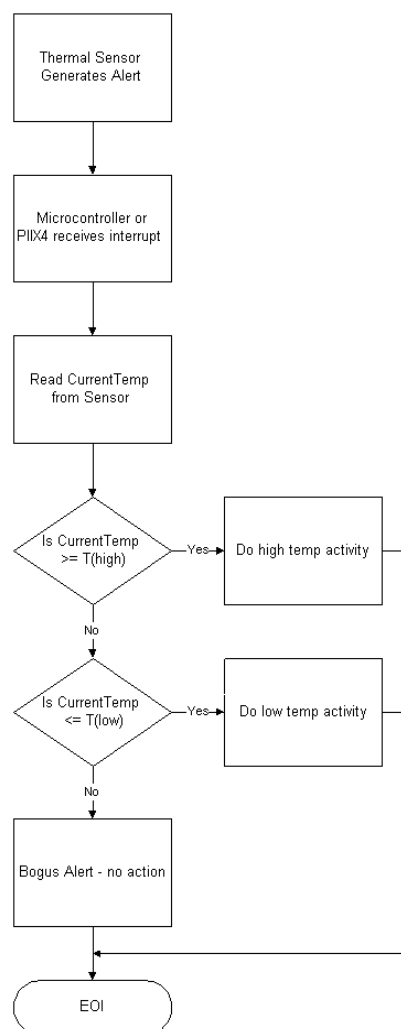
Figure 2. Workaround Flowchart: SMBALERT#-Driven System

D30. Thermal Sensor May Assert SMBALERT# Incorrectly

Under the conditions described below, the thermal sensor incorrectly generates the SMBALERT# interrupt. All of the following conditions must be met to trigger a false interrupt:

Workaround: Three different (mutually exclusive) workarounds are possible:

1. Before servicing an interrupt from the thermal sensor, read and compare the processor thermal reading with the threshold limits (T_{HIGH} or T_{LOW}). Figures 2 and 3 provide basic flowcharts for the implementation of this workaround in an interrupt driven system.
2. If the firmware implemented polls the Status Register only, then before taking any action, re-read the temperature register and do a comparison with the alarm threshold limits (T_{HIGH} or T_{LOW}) to determine if the value is actually still within the temperature window.
3. Use a temperature polling scheme to monitor the processor temperature
